The purpose of the "HOTSHEET" is to advise members of a serious incident or high potential near miss. By sharing this information and acting on the findings, we can reduce the potential for loss cause hazards to other employees, property, and equipment.

EMPLOYEE LOSS: Employee injured in recycling baler and both legs amoutated below the knee.

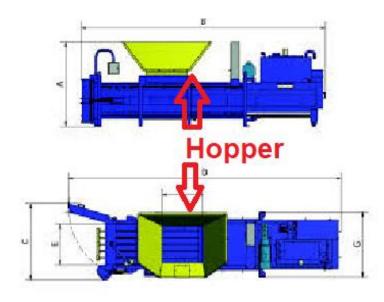
Incident Description: The employee worked in the city's recycling center. The baler is used to bale recycling material for shipping. It is believed that the recycling baler was clogged with cardboard. The operator climbed into the baler's hopper and started to jump up and down on the jammed cardboard. The cardboard jam was cleared, and the employee fell into the baler compactor operation. The baler cycled and the employee's feet were amputated.

Root Cause: Although there was signage and guarding to prevent the employee from accessing the hopper, there was no process prescribed to safely clear jams within the baler.

This is not the actual baler involved in incident.

- Develop a Lockout/Tagout program to protect employees from machine, and energy related (electrical, pneumatic, etc....) hazards.
- Develop machine specific energy control procedures.
- Develop safe process to clear jams within baler using mechanical device.
- Train affected employees on energy control policy, machine specific energy control procedures, and the new jam clearing process.
